TECHNICAL SERVICE BULLETIN

75-B-7

REAR WINDOW HEATER SWITCH

TR7

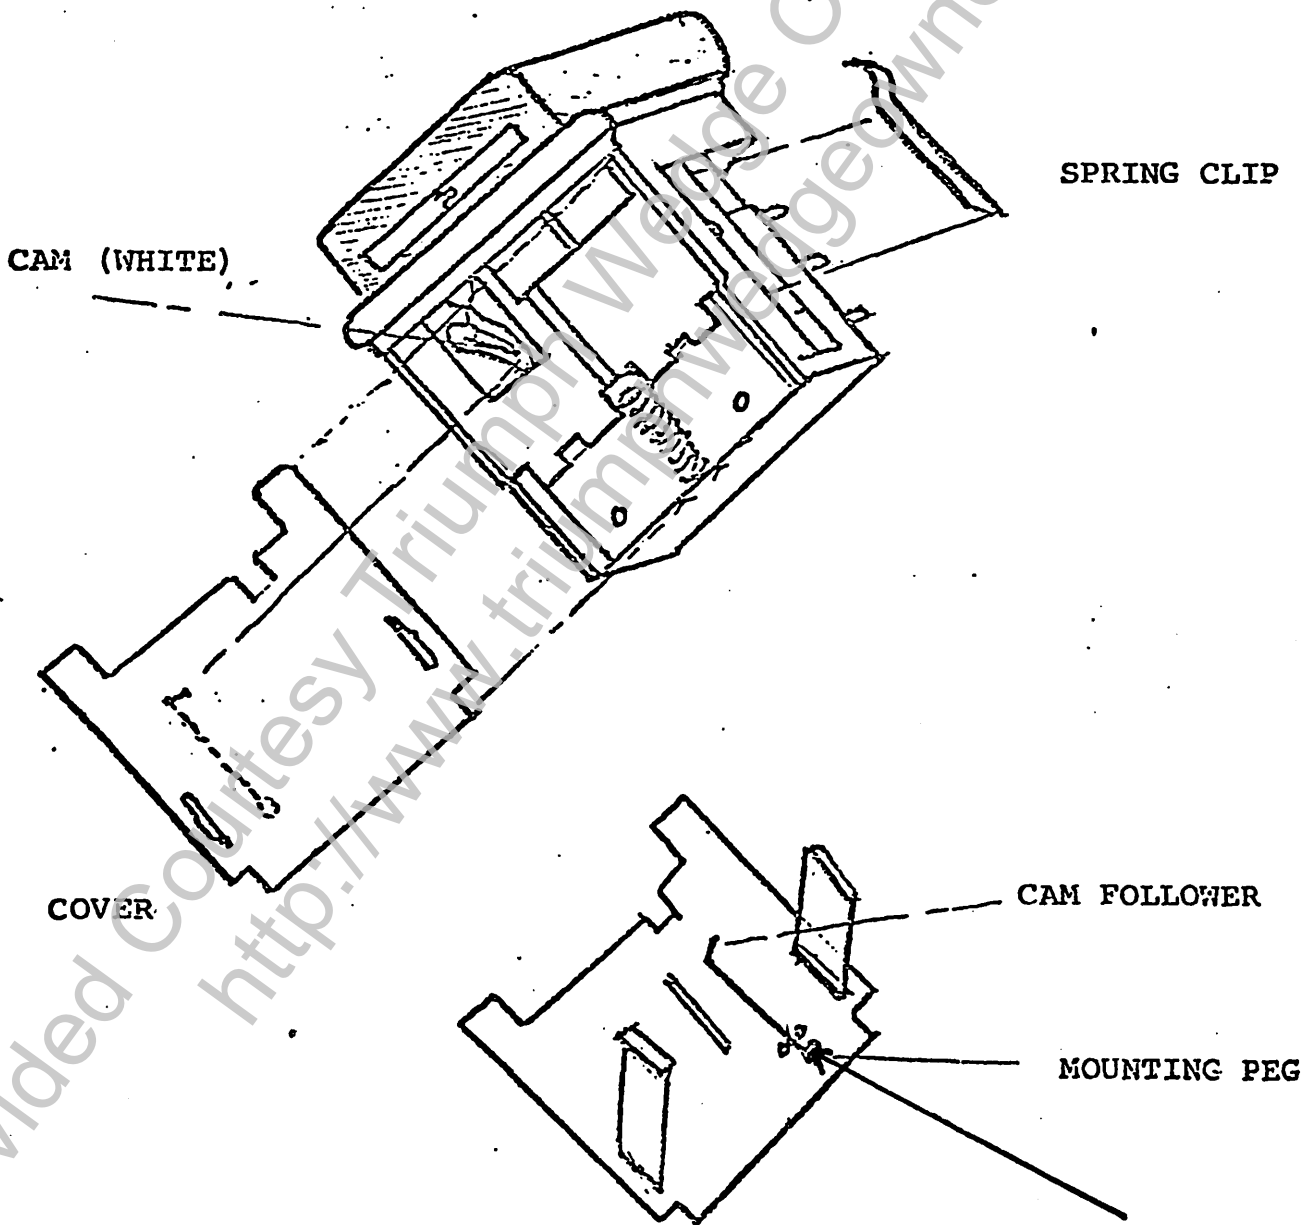
179 S A SWITCH

The drawing on the reverse side of this bulletin depicts a Lucas 179SA switch used to operate the rear window heater.

Failures of these switches have resulted from the spring type cam follower falling off its mounting peg, resulting in the switch remaining in the ON position.

1. Remove switch from vehicle
2. Note position of retaining clips which are held in by cover.
3. Flip open the cover by inserting thumb nail under rear edge.
4. Replace cam follower onto its mounting peg.
5. Apply a spot of 5 minute epoxy or alternatively super glue on top of the mounting peg as shown in the diagram and allow to harden.
6. Replace the switch retaining spring clips and cover, making sure that the cam follower enters the groove in the white plastic cam box.

Apply epoxy or super glue at this point & allow to harden.
