Triumph

April, 1975

ELIMINATION OF FACIA SQUEAKS

TR7

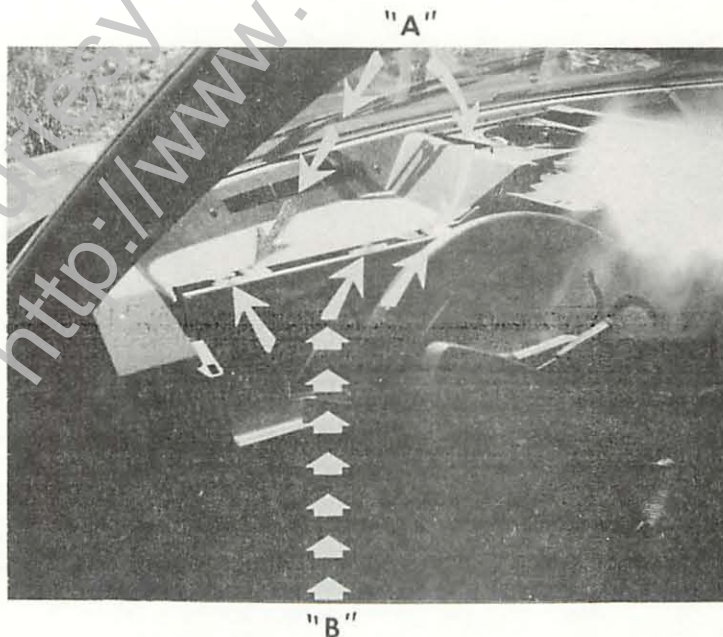
Squeaks emanating from the instrument cluster area on the TR7 can, in most cases, be eliminated by adopting the following procedure.

1. Remove the speaker grille.
2. Remove the facia instrument cowl. See Operation 76.46.17 in the TR7 Workshop Manual. This will reveal the instrument cluster attachment screws.
3. Slacken the two upper instrument cluster attachment screws (Item A). Slacken off the three attachment screws on the upper edge of the instrument lens (Item B). Grip the upper edge of the instrument cluster firmly and pull the entire assembly towards you. Holding the instrument cluster in this position, tighten the three screws securing the lens (Item B) and the two upper attachment screws (Item A).
4. Replace the facia instrument cowl and speaker grille.
