TECHNICAL SERVICE BULLETIN

76-B-11

INCORRECT POSITIONING OF HORN RELAY

TR7

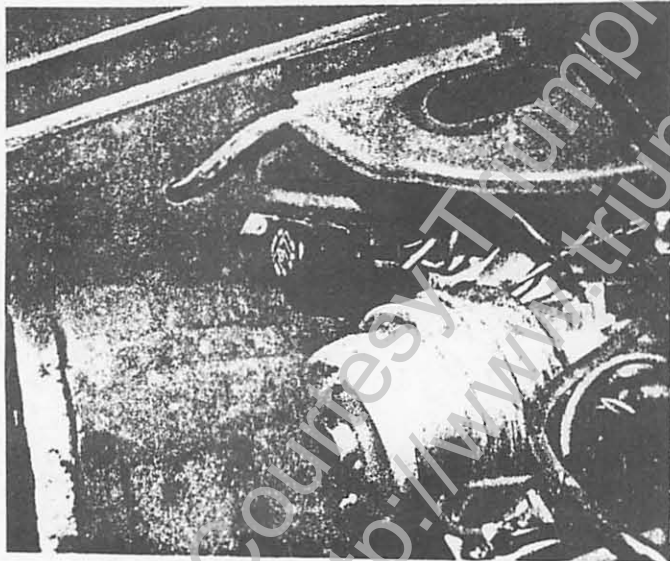
Cases have been reported where the horn relay on the TR7 has been installed in such a position as to allow water ingress.

INCORRECT POSITION

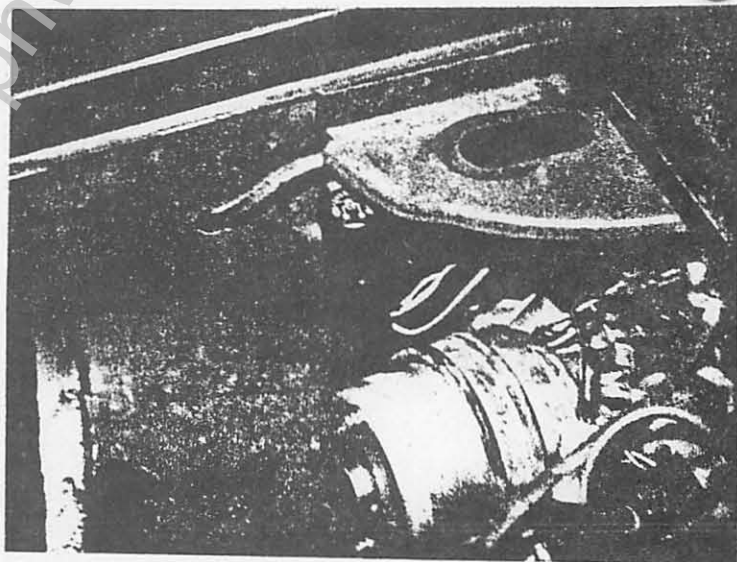
CORRECT POSITION

Please check this item during pre-delivery and/or during the next customer regular servicing interval, and if necessary re-position as shown in the diagram.
