## Triumph

September, 1976

AIR CONDITIONING FUSE FAILURE

TR7

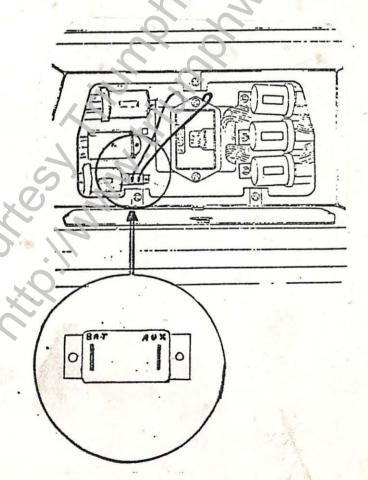
In areas where high ambients are not uncommon, the 50 AMP fuse (the top fuse on the fuse block) may fail due to the associated high head pressures within the air conditioning system.

A simple field modification has been devised whereby the fuse is removed and discarded and replaced with a 30 AMP maximum load thermo cut-out (refer to diagram).

NOTE:-It is important to connect the thermo cut-out as follows:

- Terminal marked 'BAT' is connected to the 1. brown wire terminal located on the back of the fuse box.
- Terminal marked 'AUX' is connected to the 2. purple and green wire terminal.

The fuse block has two vacant 'Lucar' male connections at these two locations.
