# Triumph

January, 1977

CRANKSHAFT SPIGOT BUSH SQUEAL

TR7

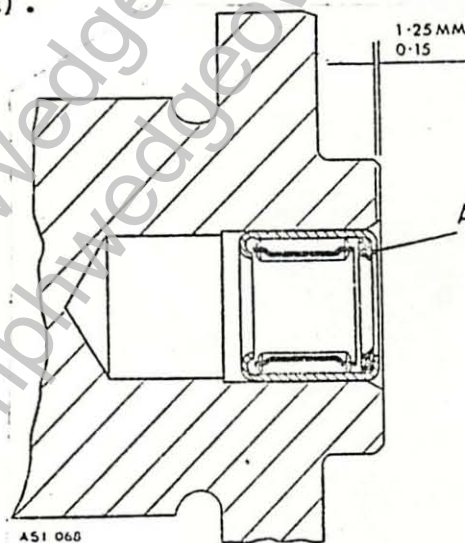
In the event that a TR7 owner should complain of a squealing noise emanating from the spigot bush in the rear of the crankshaft on 1975 and 1976 TR7s, this can be overcome by the installation of a needle roller bearing, part #UKC-8154 in place of the bronze spigot bush. (Refer to diagram).

1. Remove the gearbox.
2. Remove the clutch assembly.
3. Remove the 8 flywheel retaining bolts.
4. Remove the spigot bush retaining plate and discard.
5. Withdraw the spigot bush and discard.
6. Insert needle roller bearing, part #UKC-8154, with the integral seal A (refer to illustration) facing the gearbox side. The needle roller bearing is to be pressed into the crankshaft to the dimension shown in diagram.
