NO. 79/Z/4

Recall Campaign Bulletin

RECALL CAMPAIGN A457
HEADLAMP MOTOR

1975-78 TR7

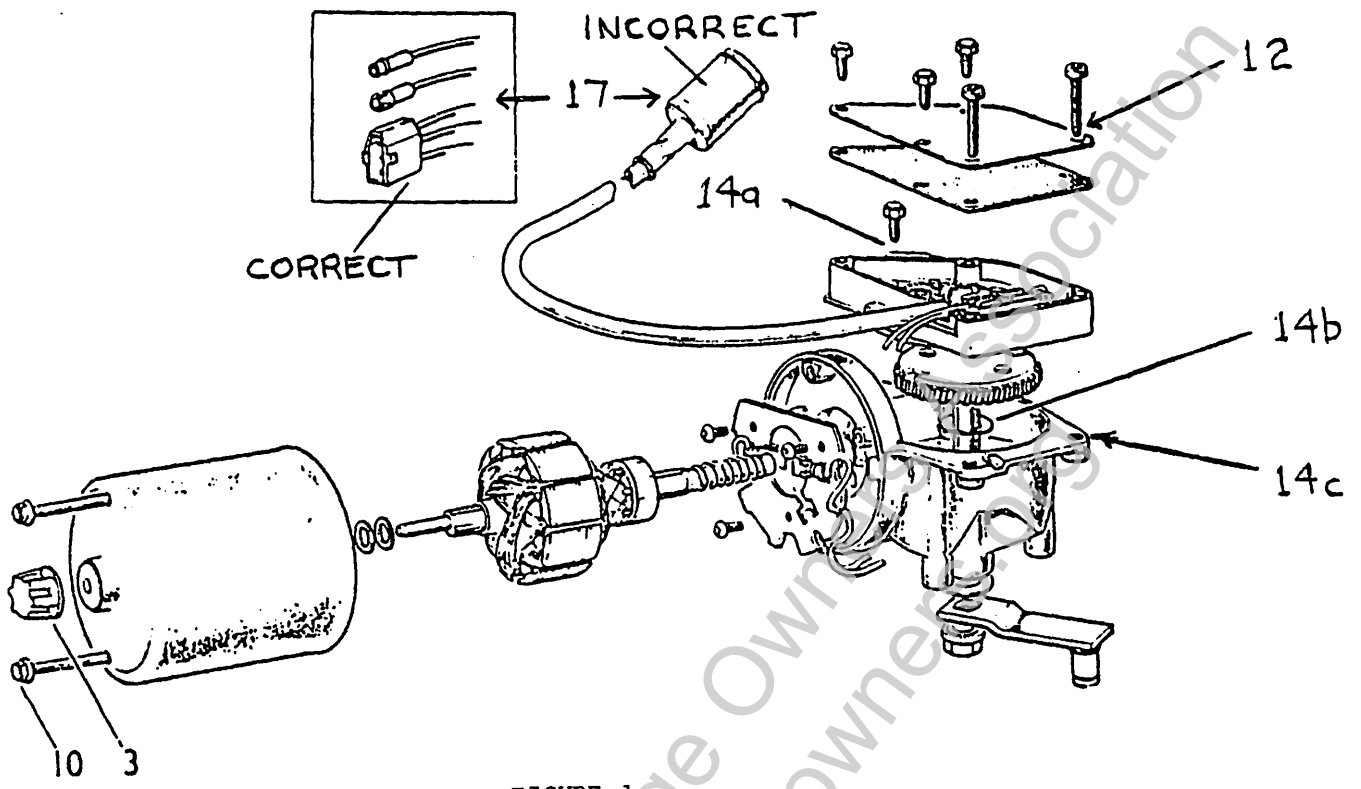
FIGURE 1.

13. Check for evidence of corrosion i.e., green deposits (verdigris) on copper strips and rivet heads.
 - (i) If there is NO corrosion present, carry out operation 14(e) onwards.
 - (ii) If corrosion IS present the limit switch must be replaced using the following procedure.

12. Remove the 5 cover fixing screws, (5/16" nut runner), top cover, liner and foam gasket. (Retain top cover and screws for reassembly). (Figure 1 (12)).

14. Lift out and disconnect the red and blue motor leads from the
 - (a) switch assembly. Remove the 6th screw and lift the switch assembly from the motor gearbox. (Figure 1 (14a)).

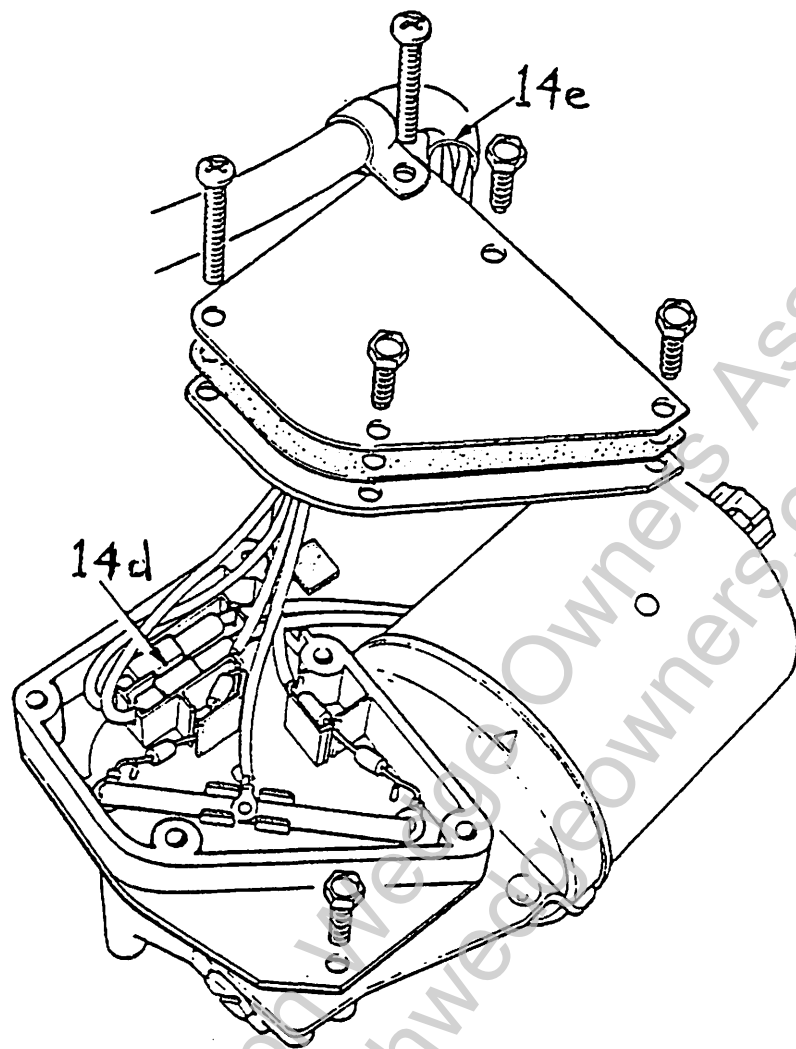
FIGURE 3.

On units where the cable sleeve is clamped by a plastic harness clip to the switch box cover (see Figure 3) and the cables terminate in two single and one triple connector, no action is required.

The remaining 5 leads are then placed side by side on top of the small foam pad followed by the large foam pad, the liner and the original top cover. The original screws are then used to secure the top plate and harness clip mounted adjacent to the cable entry position. (See Figure Number 3).
