# TECHNICAL SERVICE BULLETIN

77-B-1

HEAD LAMP FEED WIRE SECURITY

TR7

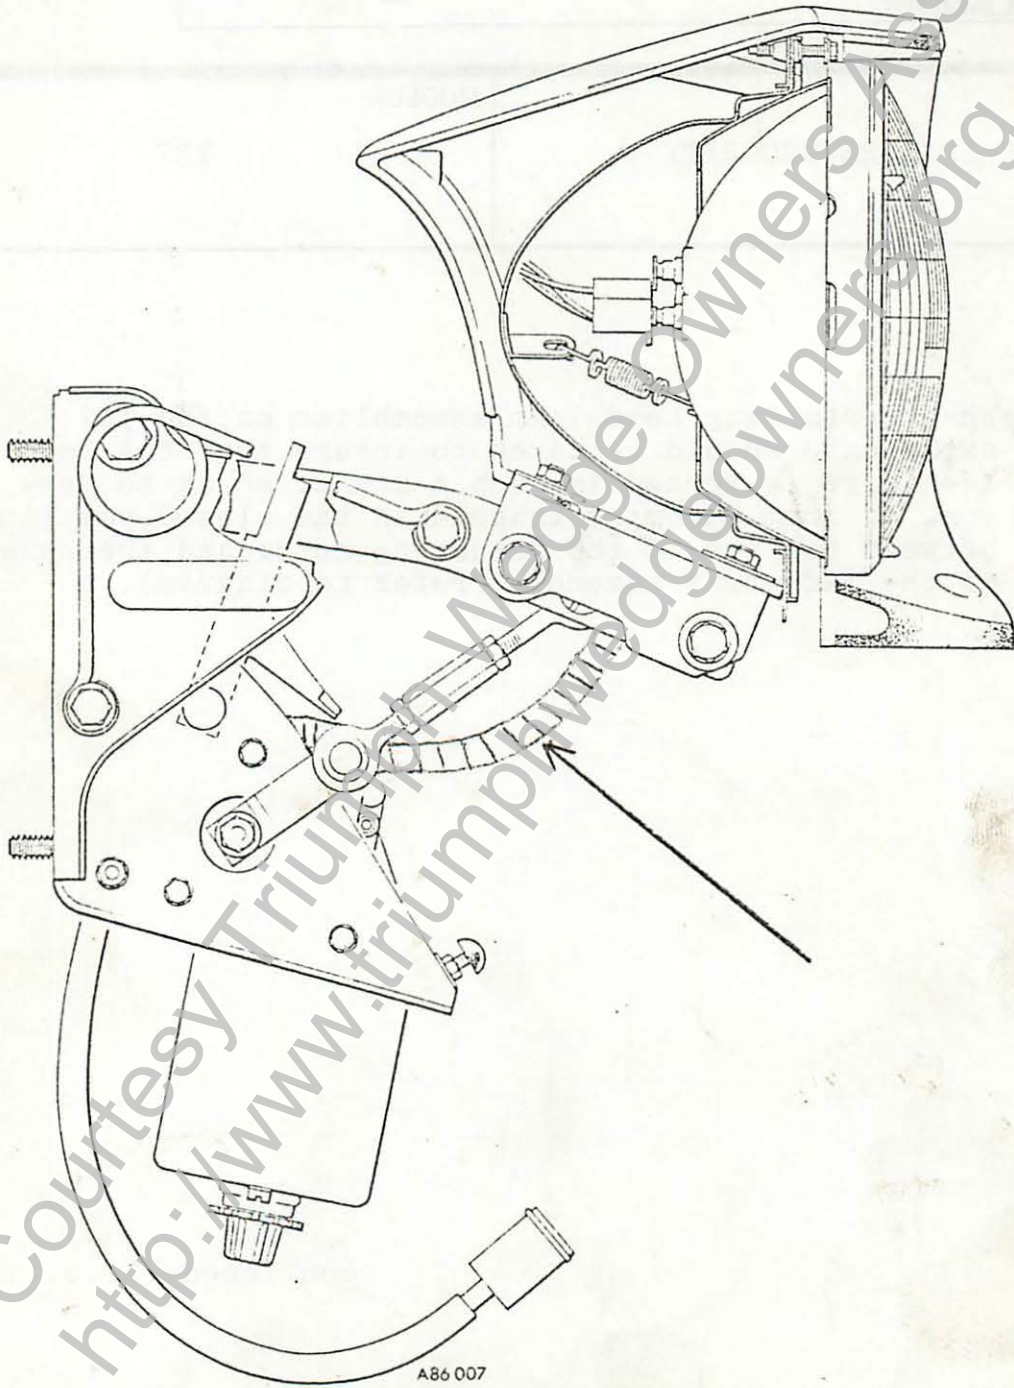
When installing head lamp assemblies on the TR7, extra care should be taken to insure that the lamp feed wire is routed in such a manner so as to prevent it from becoming trapped in the closed position, between the top of the actuating motor and the base of the lamp tray assembly (refer to diagram).
